Durakwikstone

TEST REPORT

Ledgestone Panel

200422012SHF-001

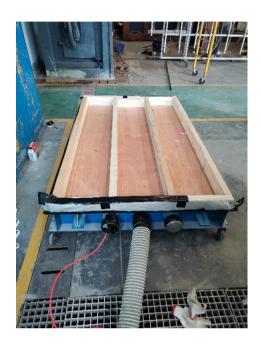
Fig.3 Negative load test set-up

Table 2 Negative Load Test

Panel #	Observations			
1	The panel was broken at the test load of 115 psf.			
2	The panel was broken at the test load of 140 psf.			
3	The panel was broken at the test load of 124 psf.

Note: The load was applied to the panel and increased in 10 psf increments and the load was held for 10 seconds at each increment.

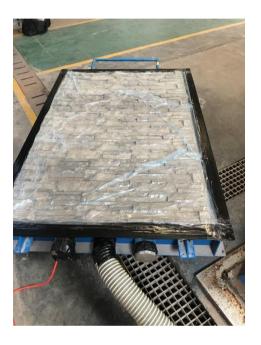
Fig.5 Positive load test set-up

Table 1 Positive Load Test

Panel #	Observations			
1	There was no any damage of the panel at the ultimate load of 200 psf.			
2	There was no any damage of the panel at the ultimate load of 200 psf.			
3	There was no any damage of the panel at the ultimate load of 200 psf.			
N . 7

Note: The load was applied to the panel and increased in 15 psf increments and the load was held for 10 seconds at each increment. The ultimate load is 200 psf.
